STRUCTURAL AUDIT REPORT WITH
RECOMMENDATION LETTER
DATE:- 13/02/2024 FOR
PARSEE GYMKHANA (G+01), MARINE LINES,
MUMBAI - 400 002.

Sub: Submission of single page entire report summary for visual survey & structural audit of Parsee Gymkhana, Marine Lines.

Details of structure: - The building constitutes of Ground + 1 Floors (RCC composite load bearing Frame Structure)

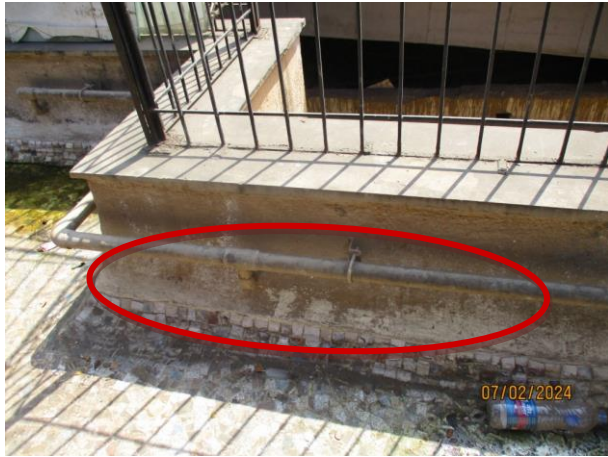
CRACKS AT CHINA CHIPS TOP SURFACE

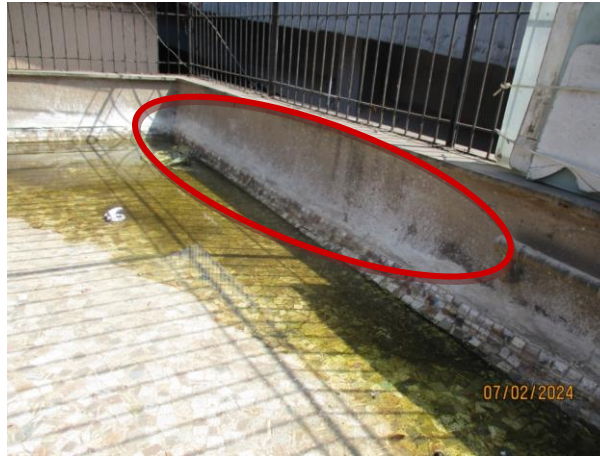
CRACKS AT PARAPET WALL PLASTER

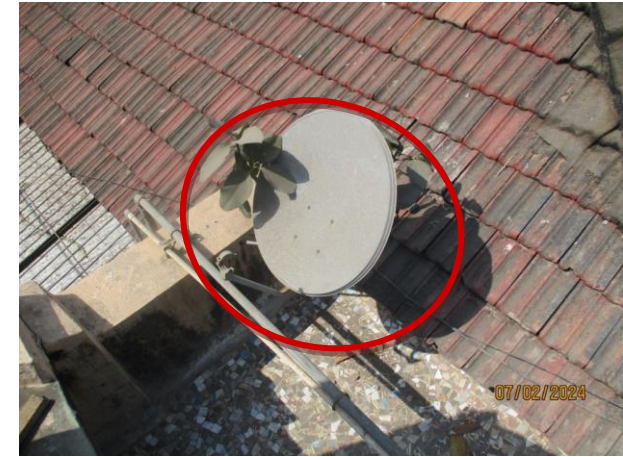
VEGETATION GROWTH AT TOP SURFACE OF TERRACE

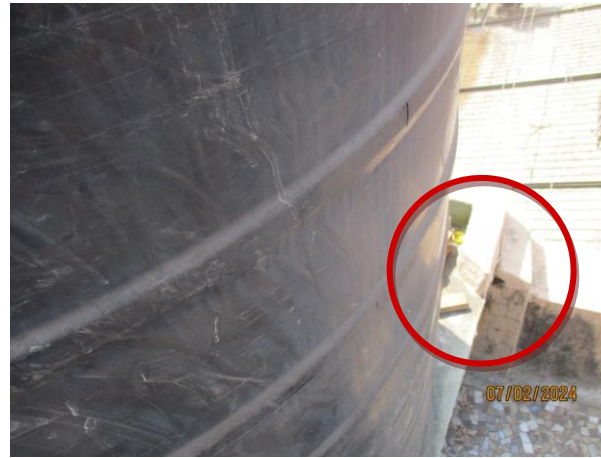
FINE CRACKS AT PLASTER

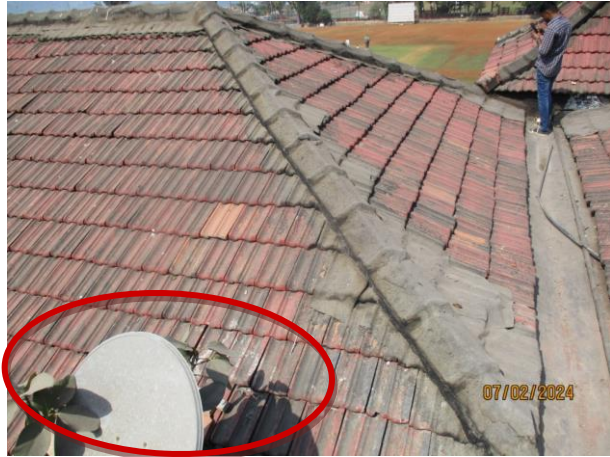
VEGETATION GROWTH AT MANGLORE TILES

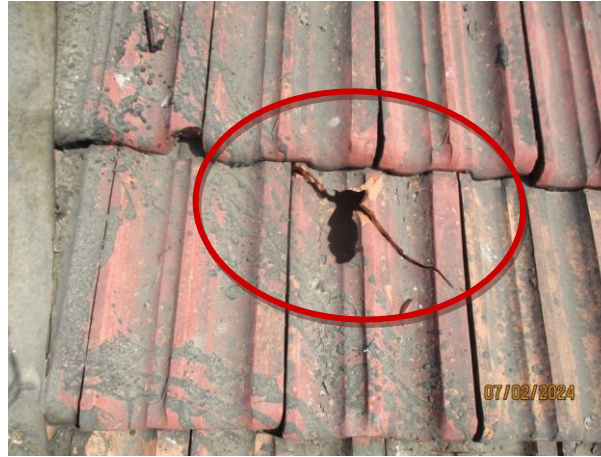
MANGLORE TILES FOUND DAMAGED

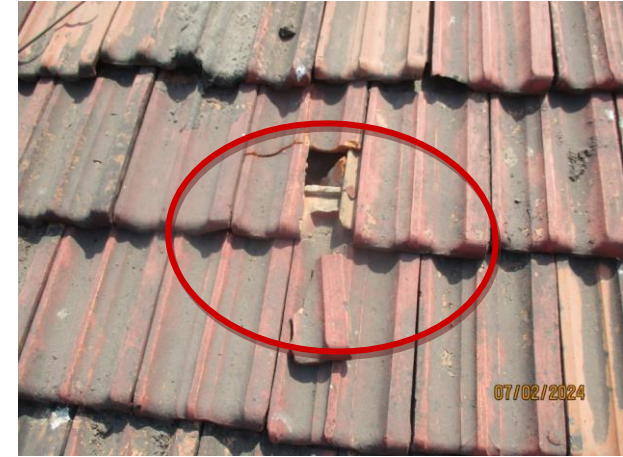
MANGLORE TILES FOUND DAMAGED

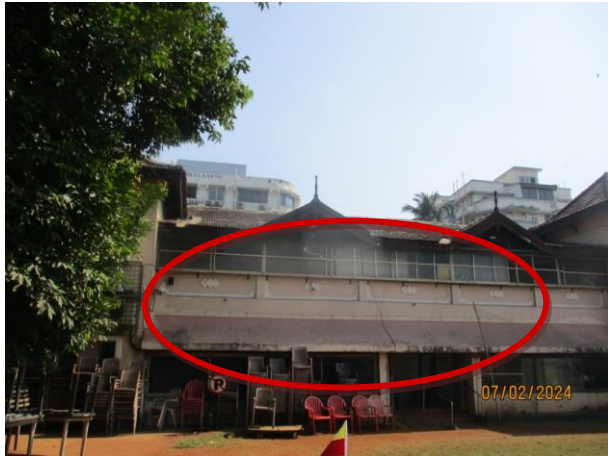
BLACK FUNGUS & CRACKS AT WALL PLASTER

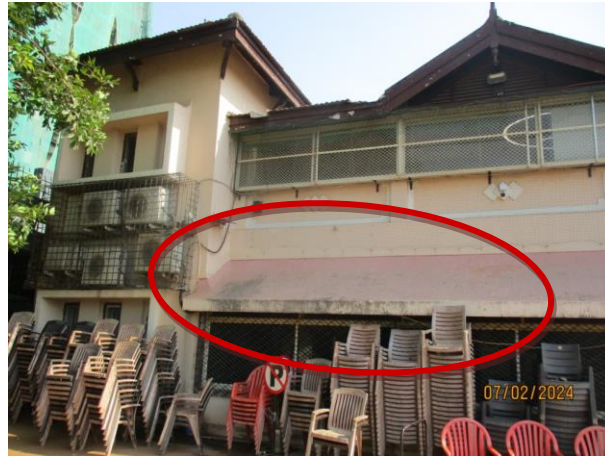
BLACK FUNGUS & CRACKS AT WALL PLASTER

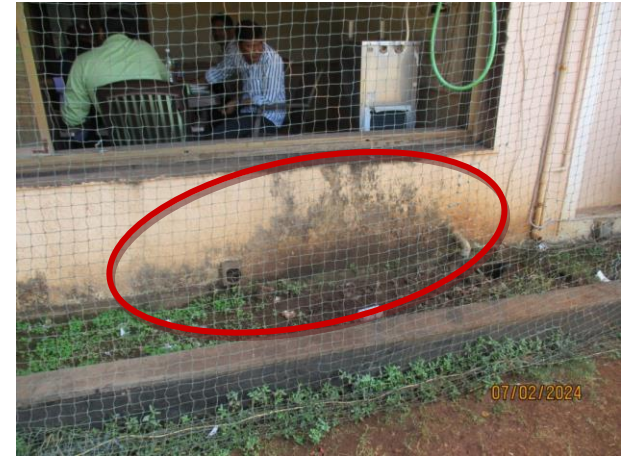
BLACK FUNGUS AT WALL PLASTER

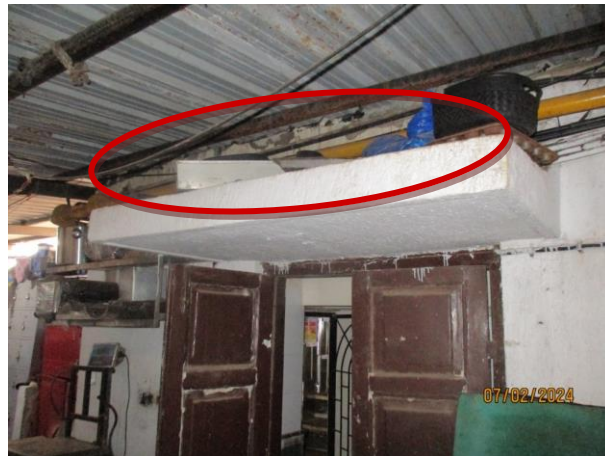
CRACKS AT WALL PLASTER

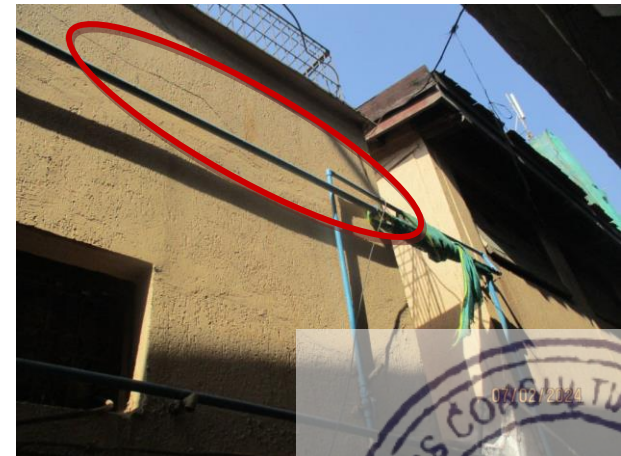
CRACKS AT WALL PLASTER

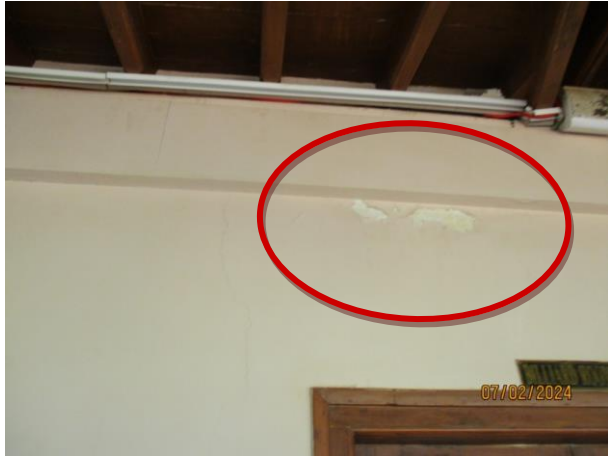
FLAKING OF PAINT AT WALL

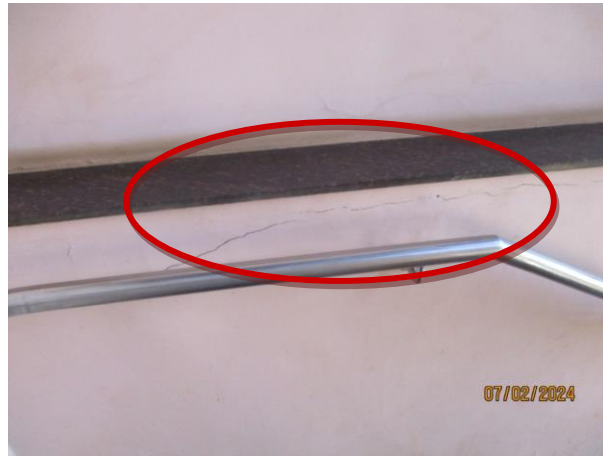
CRACKS AT WALL

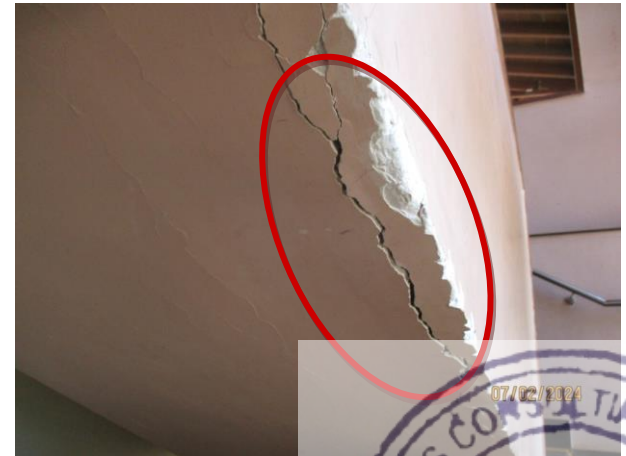
CRACKS AT CEILING PLASTER

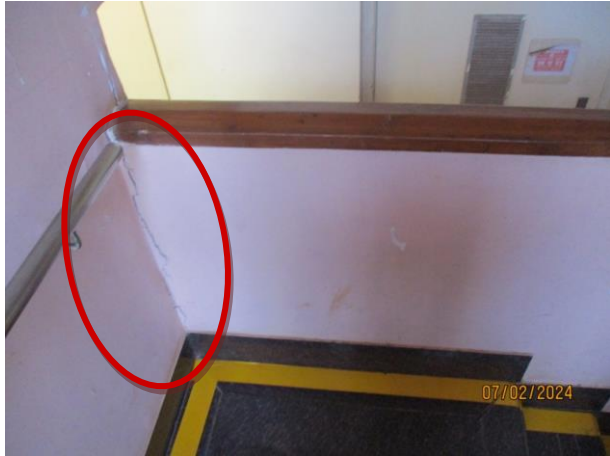
CRACKS AT WALL PLASTER

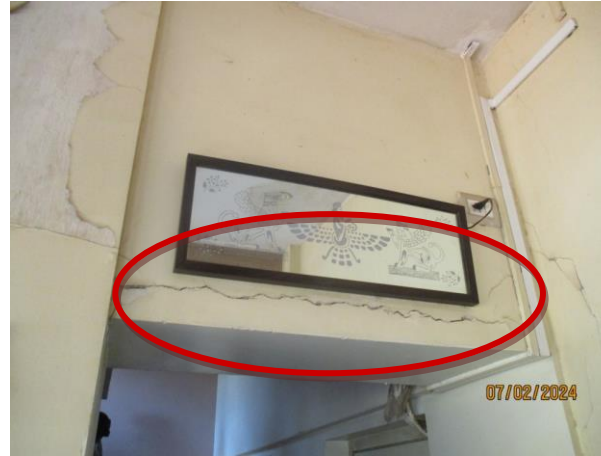
CRACKS AT BEAM

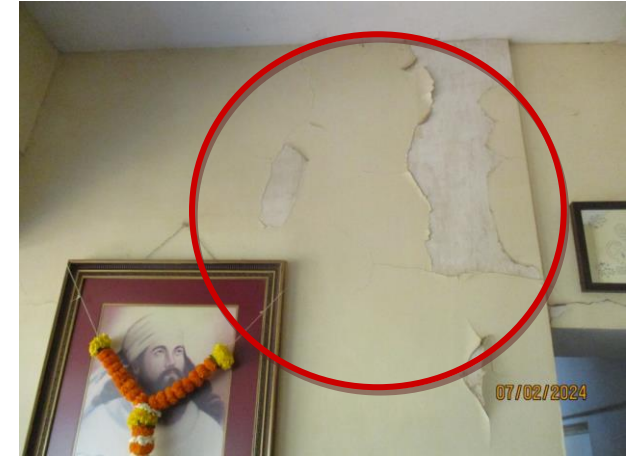
FLAKING OF PAINT AT WALL

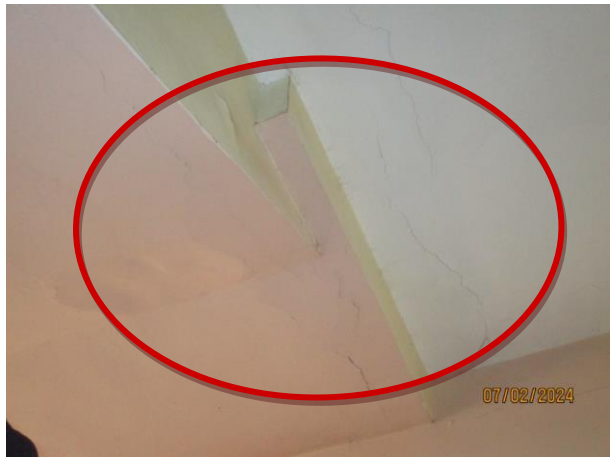
CRACKS AT CEILING

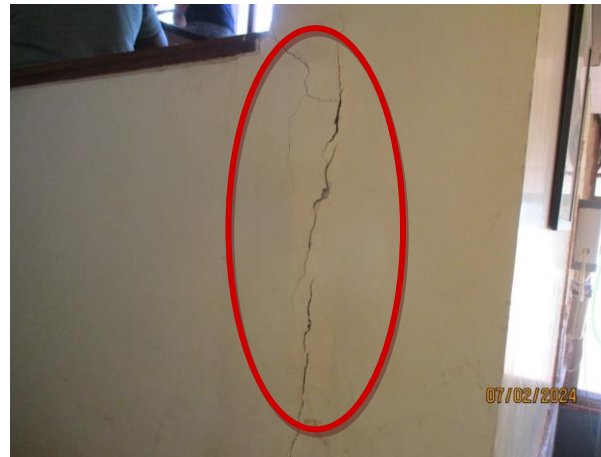
CRACKS AT WALL

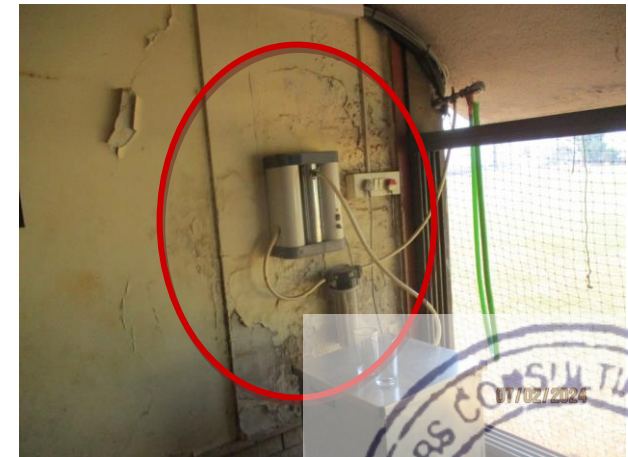
FLAKING OF PAINT AT WALL

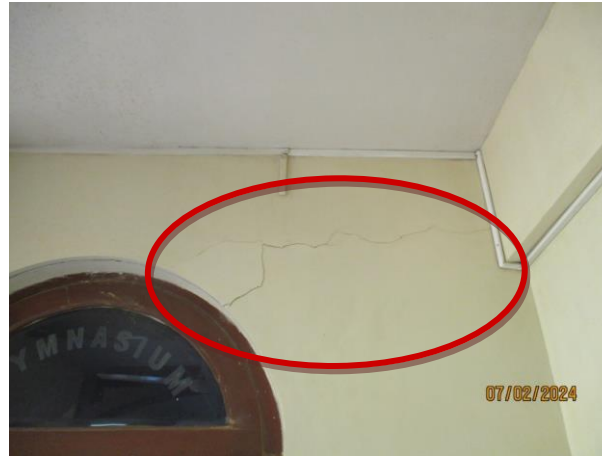
CRACKS AT WALL

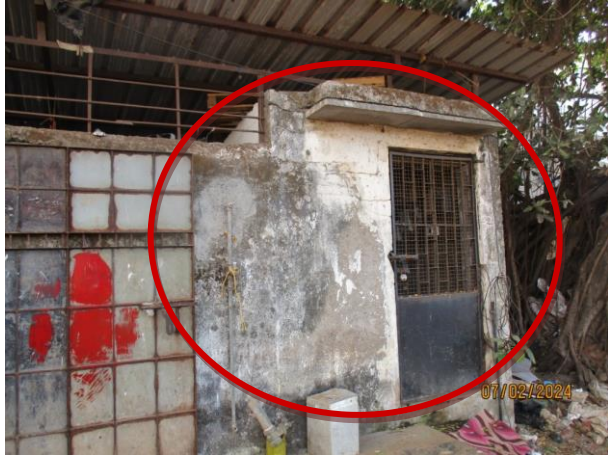
CRACKS AT EXTERNAL WALL PLASTER

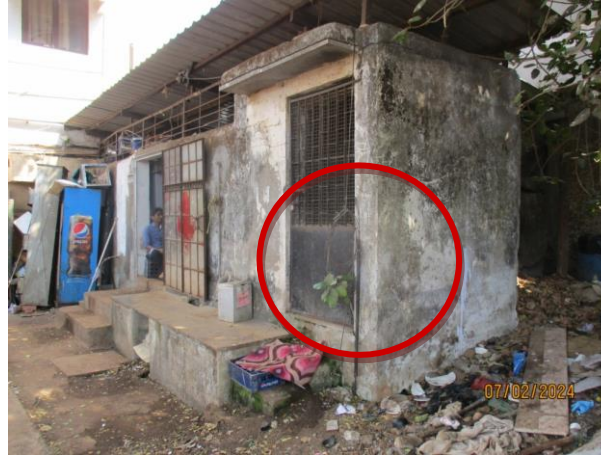
VEGETATION GROWTH FROM WALL

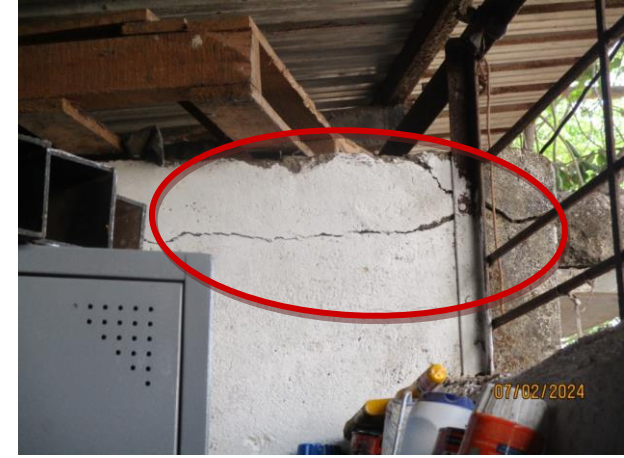
CRACKS AT WALL

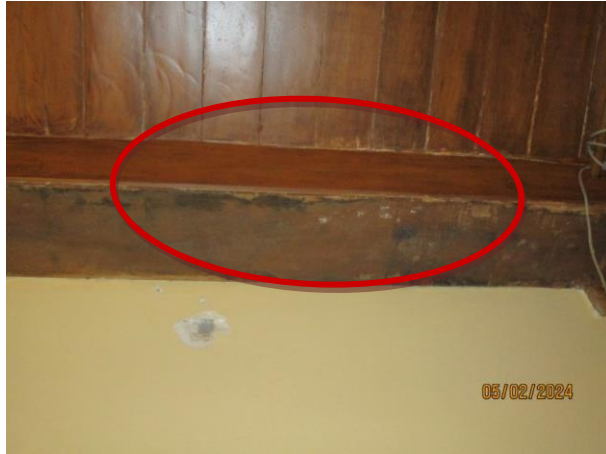
BANQUET HALL - SEEPAGE MARKS AT WOODEN CEILING

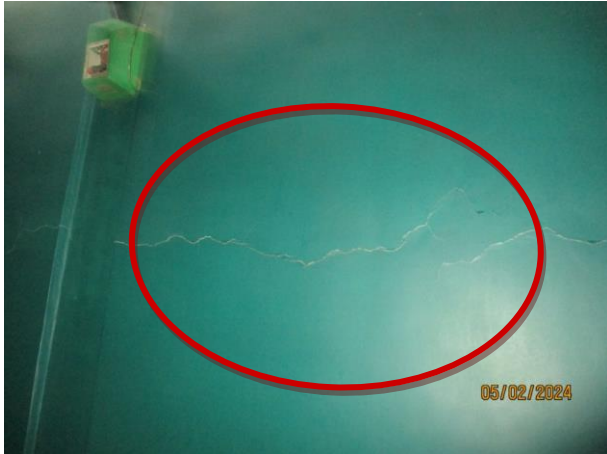
**BADMINTON ROOM - CRACKS AT WALL
PLASTER**

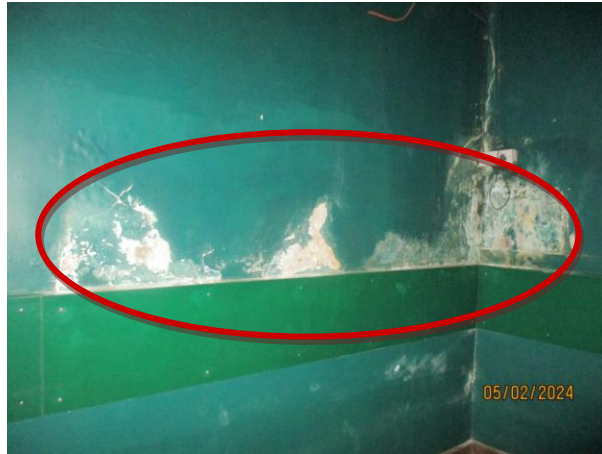
**BADMINTON ROOM - FLAKING OF PAINT AT
WALL**

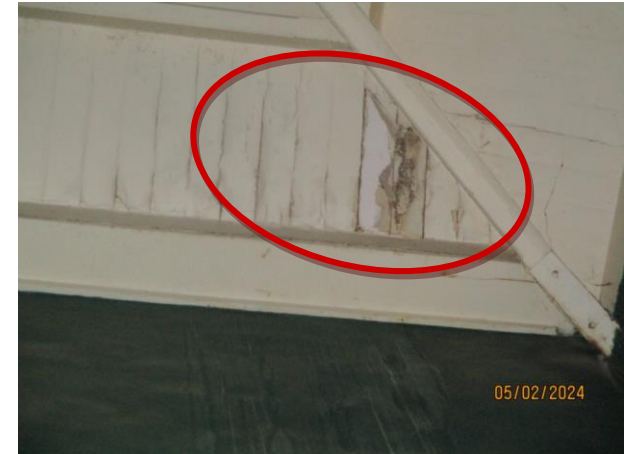
**BADMINTON ROOM - WOODEN ROOF FOUND
IN ROTTEN CONDITION**

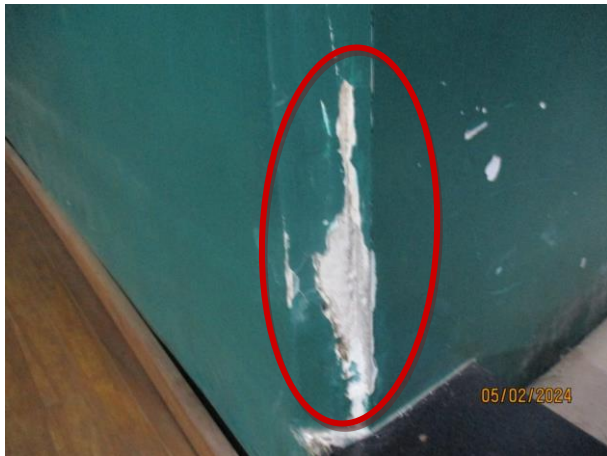
**BADMINTON ROOM - FLAKING OF PAINT AT
WALL**

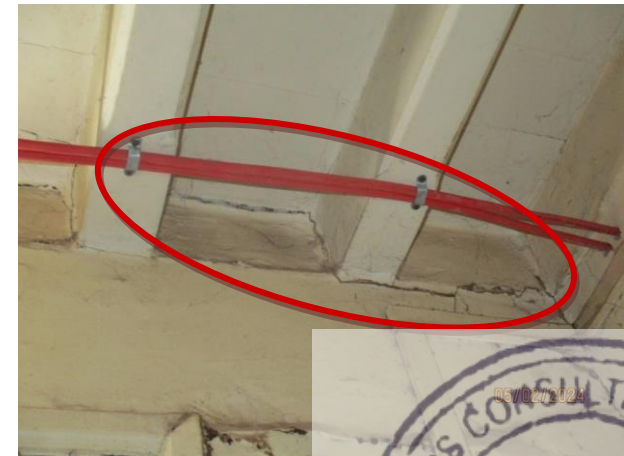
**BADMINTON ROOM - CRACKS AT WALL
PLASTER**

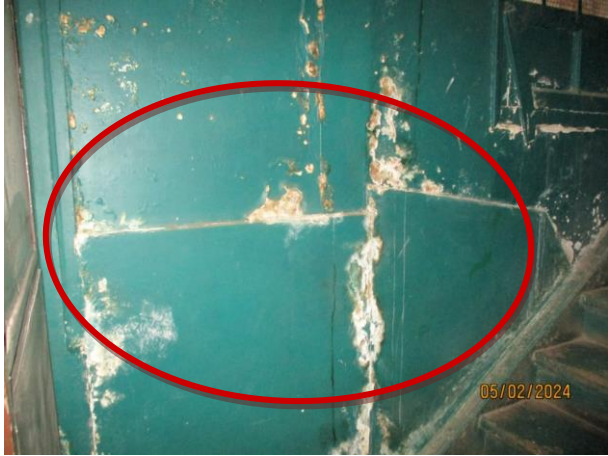
BADMINTON ROOM - FLAKING OF PAINT AT WALL

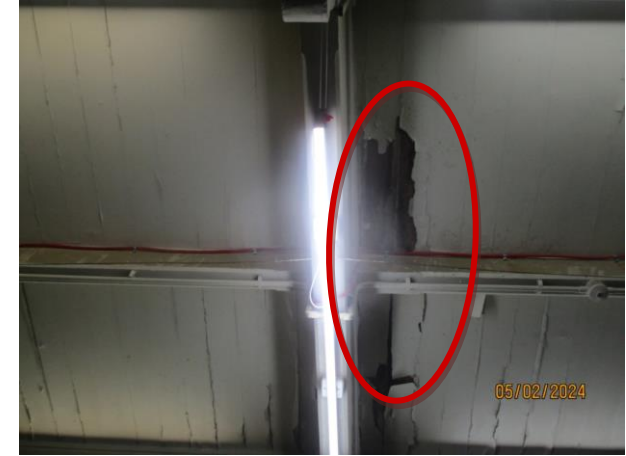
BADMINTON ROOM - BAD CONDITION OF ROOF AREA

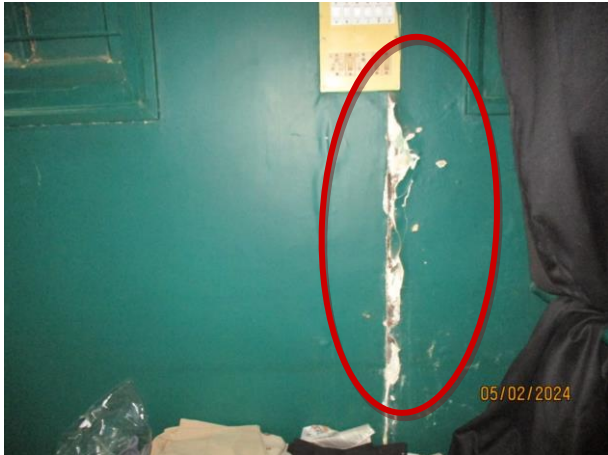
BADMINTON ROOM - FLAKING OF PAINT AT WALL

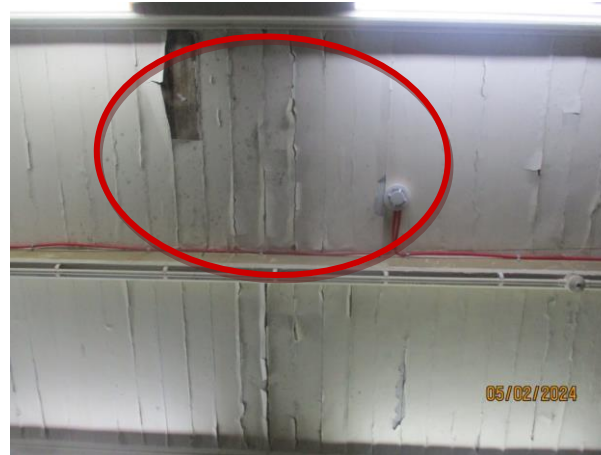
BADMINTON ROOM - CRACKS & LOOSE PAINT AT WOODEN ROOF AREA S

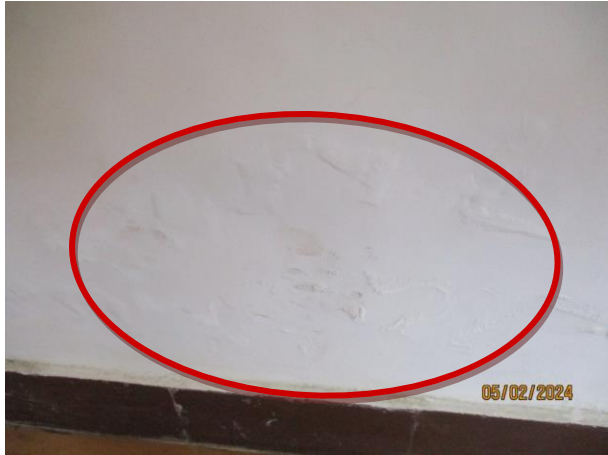
BILLIARD ROOM - FLAKING OF PAINT AT WALL

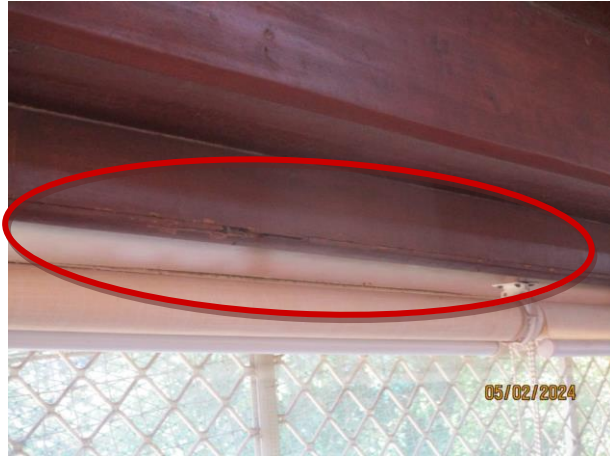
CARD ROOM - CRACKS AT LINTEL BEAM
PLASTER

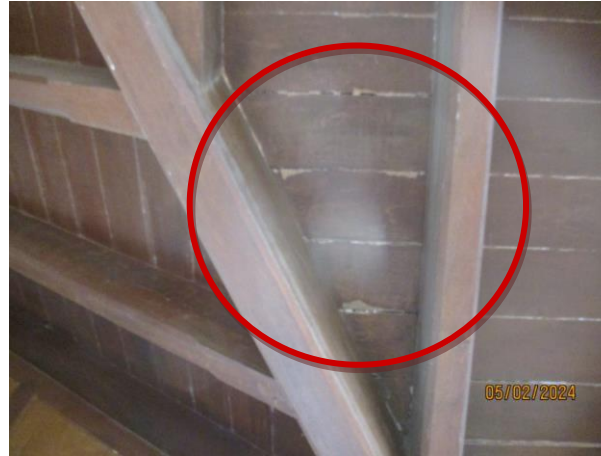
CARD ROOM - JOINTS ARE OPEN BETWEEN
WOODEN PLANKS

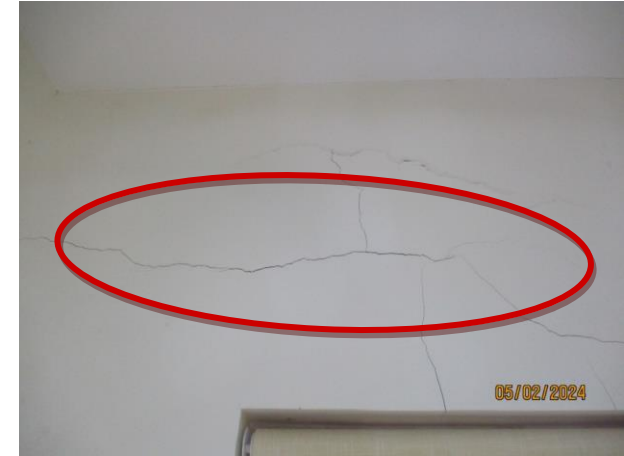
CARD ROOM - MULTIPLE CRACKS AT WALL
PLASTER

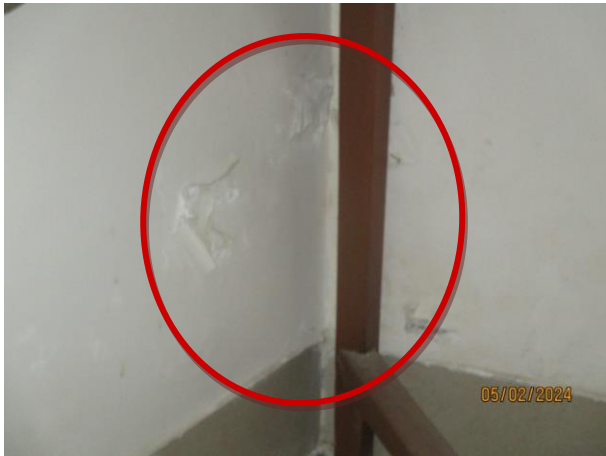
CARD ROOM - FLAKING OF PAINT AT WALL

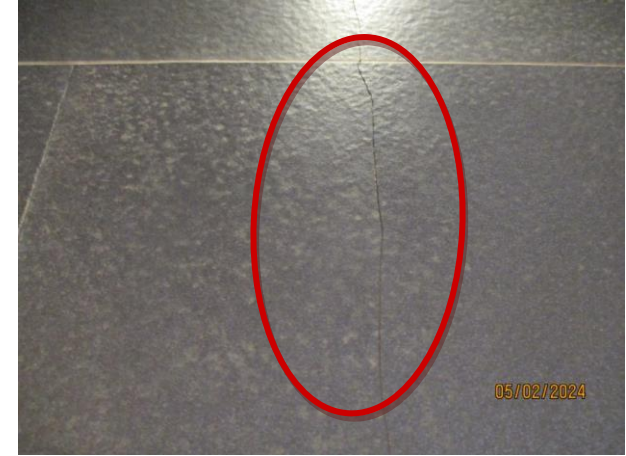
CLEAN BOWL (DINING ROOM) - CRACKS AT WALL TILES

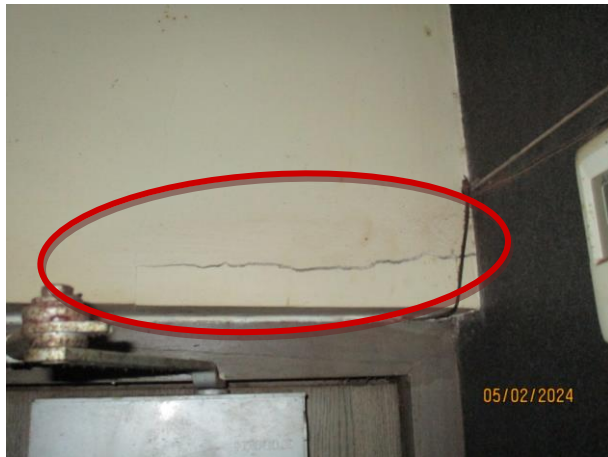
CLEAN BOWL (DINING ROOM) - CRACKS AT WALL

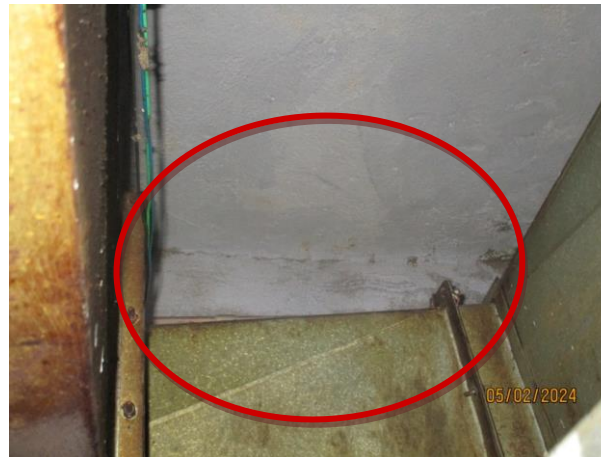
CLEAN BOWL (DINING ROOM) - FLAKING OF PAINT AT CEILING

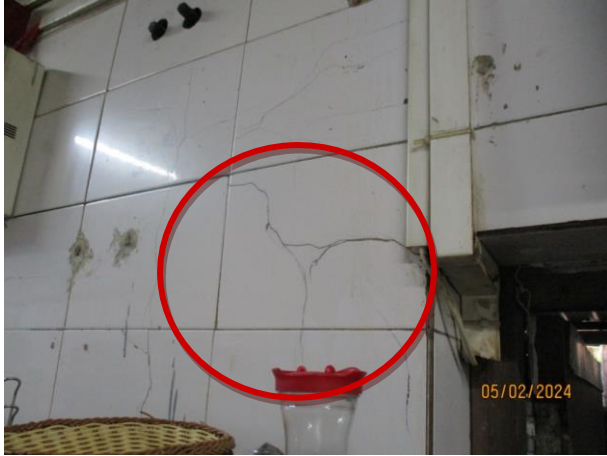
**CLEAN BOWL (DINING ROOM) - CRACKS AT
WALL TILES**

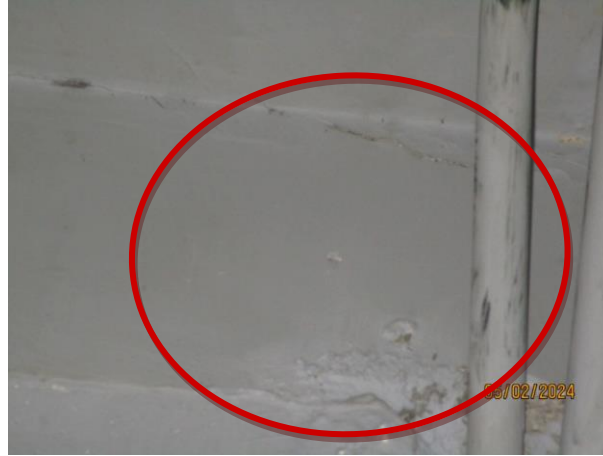
**CLEAN BOWL (DINING ROOM) - CRACKS &
FLAKING OF PAINT AT WALL & CEILING**

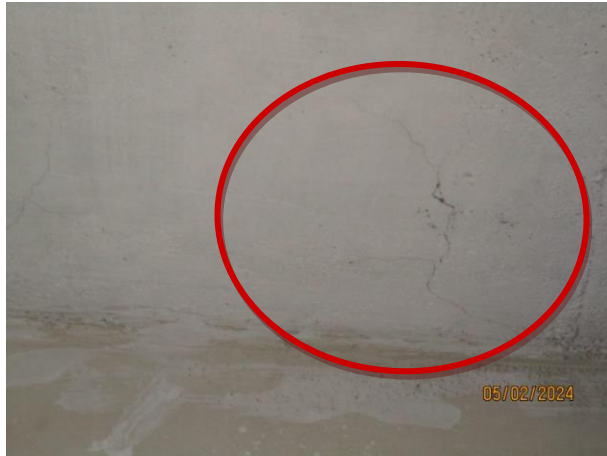
GYMKHANA OFFICE - CRACKS AT CEILING

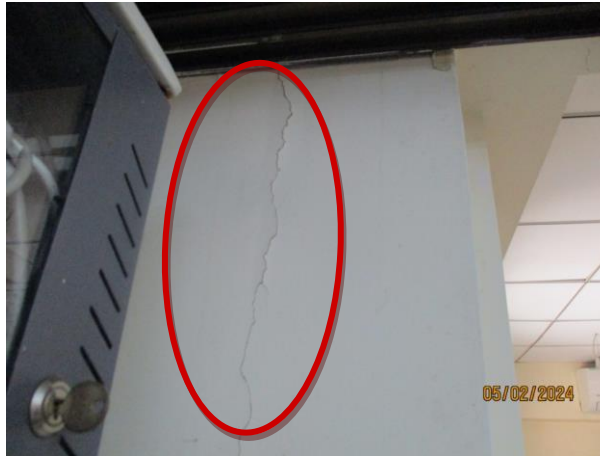
GYMKHANA OFFICE - CRACKS AT WALL

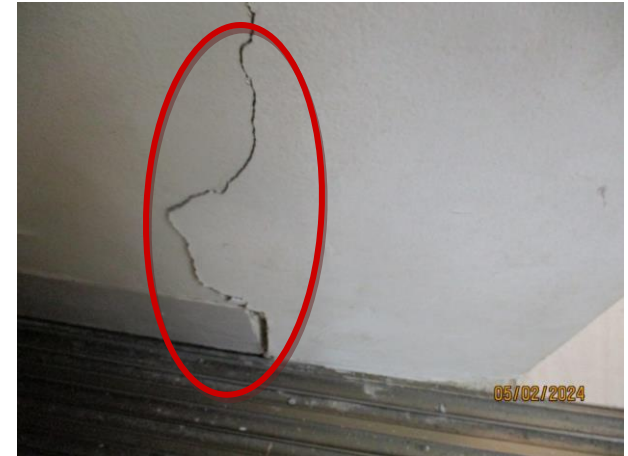
GYMKHANA OFFICE - CRACKS AT WALL

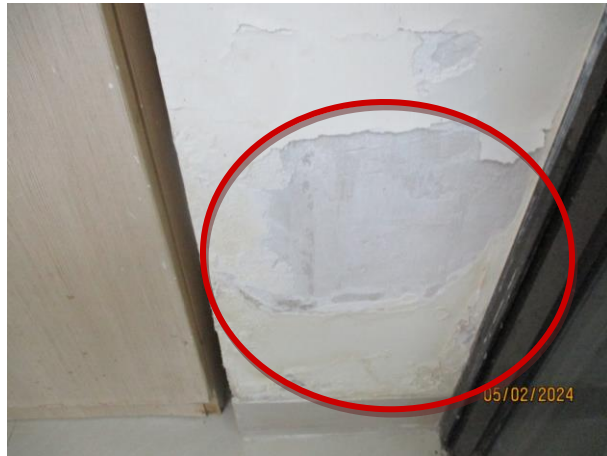
GYMKHANA OFFICE - FLAKING OF PAINT AT WALL

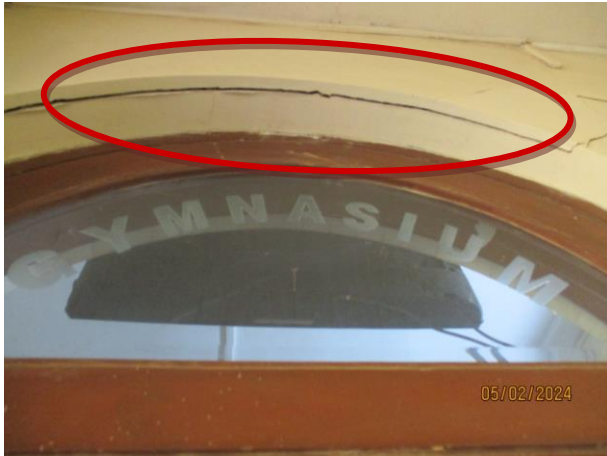
GYMNASIUM - CRACKS AT WALL

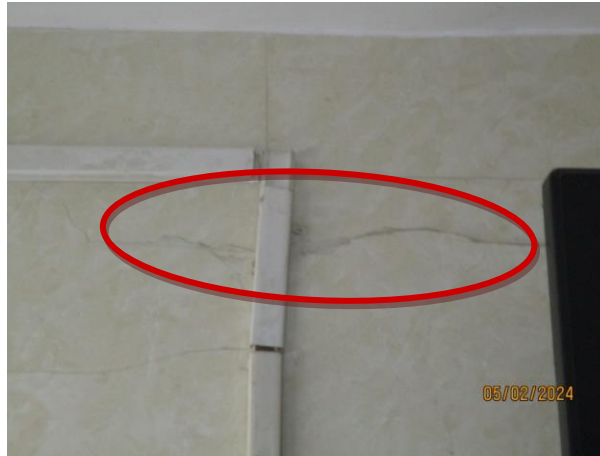
GYMNASIUM - CRACKS AT WALL

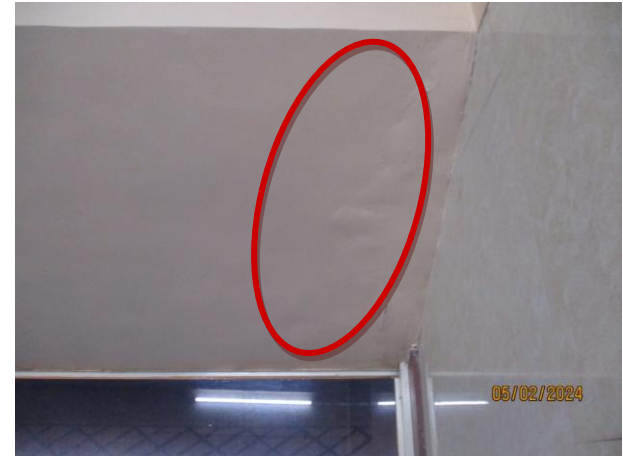
GYMNASIUM - FLAKING OF PAINT AT CEILING

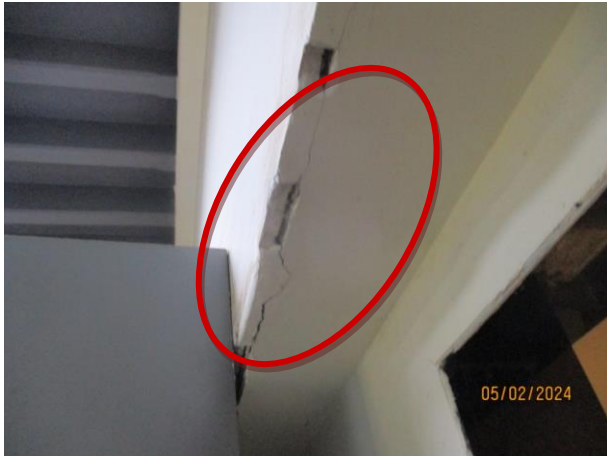
MEMBERS LOCKER ROOM - CRACKS AT BEAM

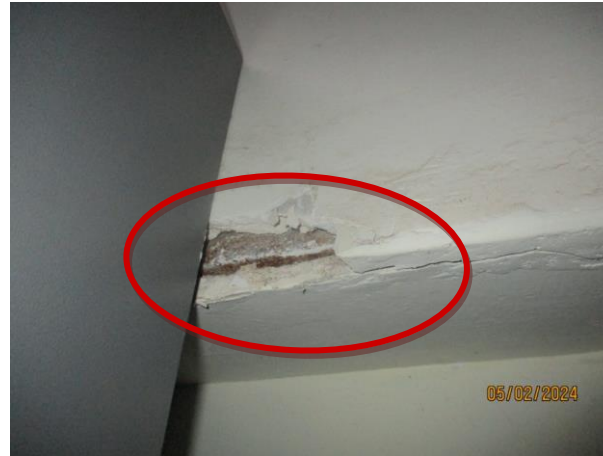
MEMBERS LOCKER ROOM - CRACKS AT BEAM
CORRODED STEEL BARS EXPOSED

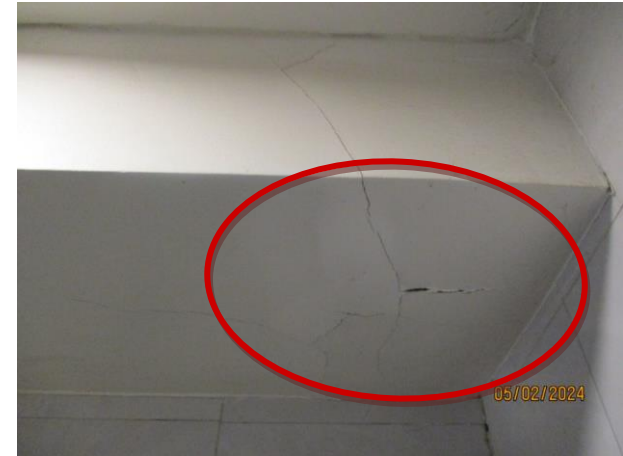
MEMBERS LOCKER ROOM - CRACKS AT BEAM
BOTTOM

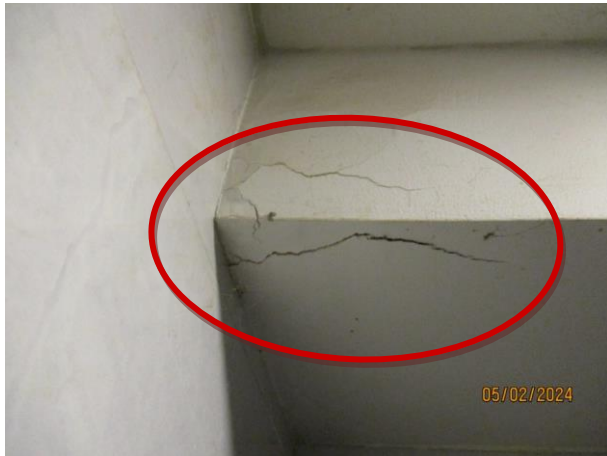
MEMBERS LOCKER ROOM - CRACKS AT BEAM
BOTTOM

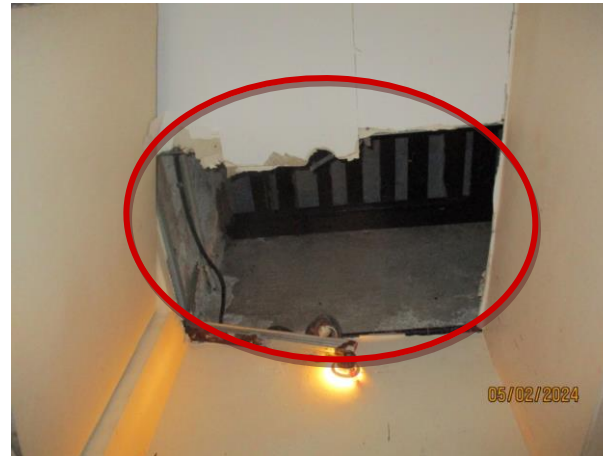
MEMBERS LOCKER ROOM - DAMAGED FALSE
CEILING OBSERVED

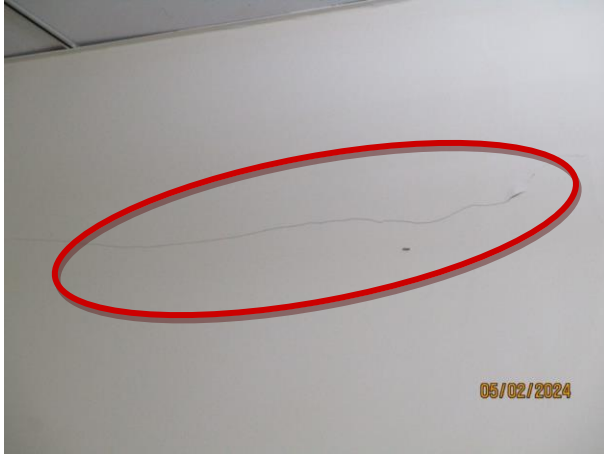
SECRETARY OFFICE - CRACKS AT WALL

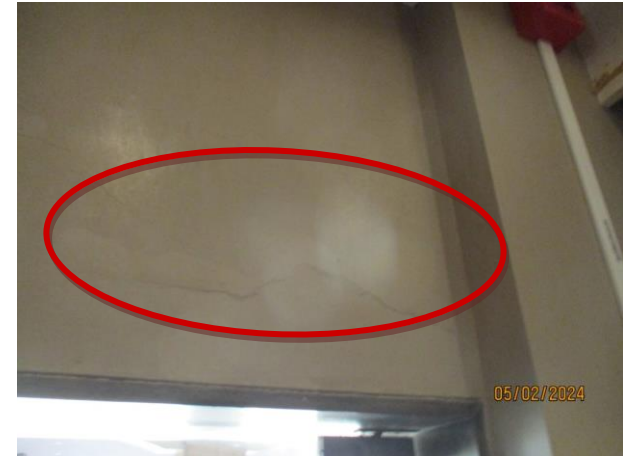
SILLY POINT (BAR) - CRACKS AT WALL

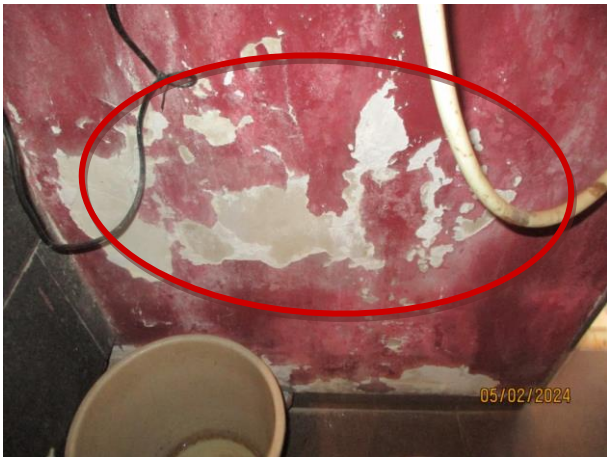
SILLY POINT (BAR) - FLAKING OF PAINT AT WALL

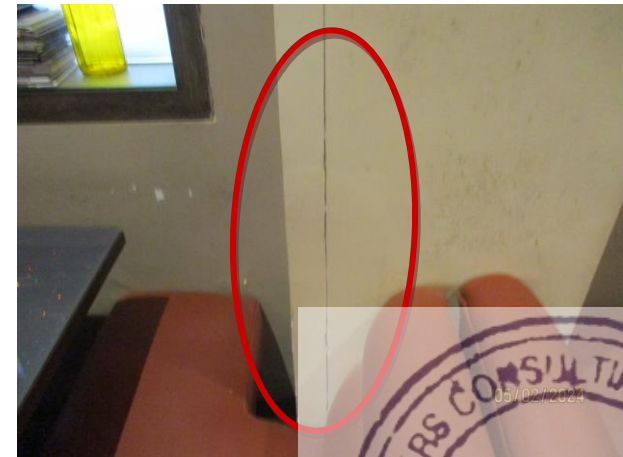
SILLY POINT (BAR) - CRACKS AT WALL

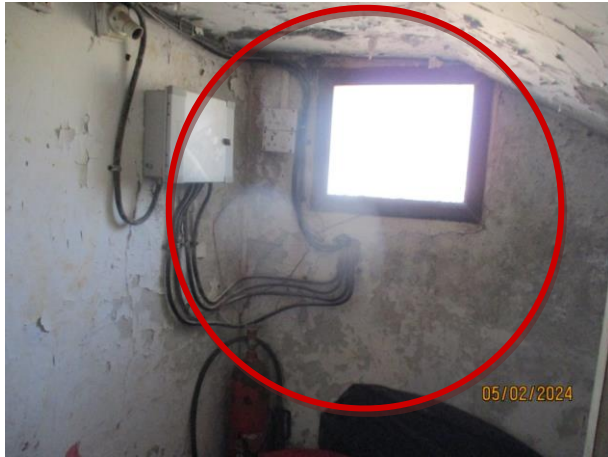
STAIRCASE BOTTOM AREA - CRACKS & FLAKING OF PAINT AT WALL

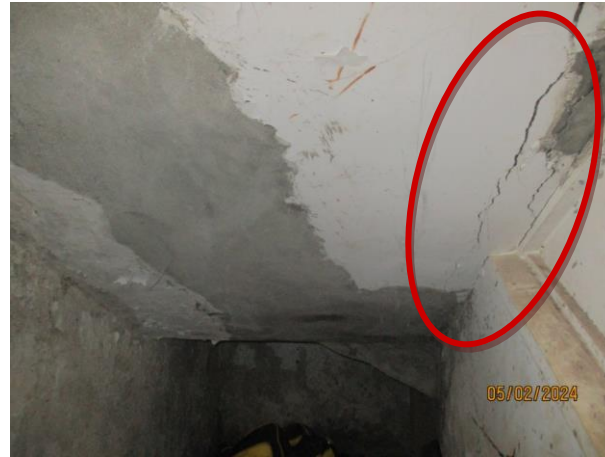
STAIRCASE BOTTOM AREA - CRACKS AT CEILING

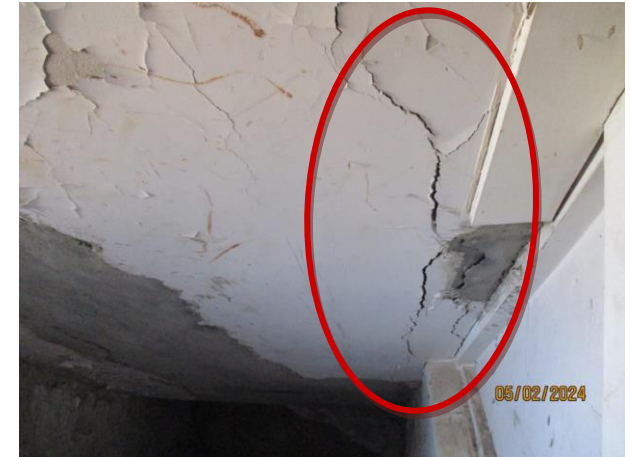
STAIRCASE BOTTOM AREA - CRACKS AT CEILING

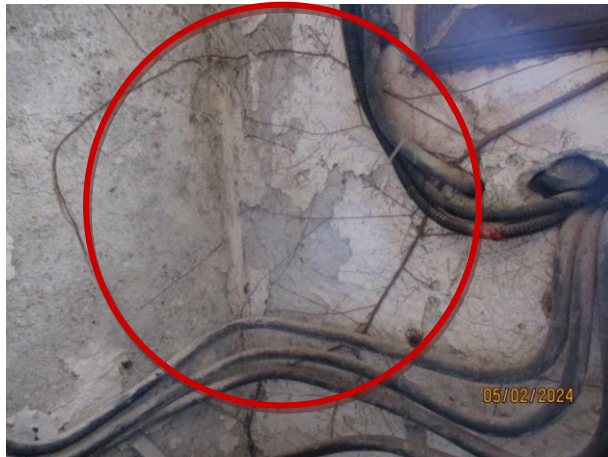
STAIRCASE BOTTOM AREA - FLAKING OF PAINT AT WALL

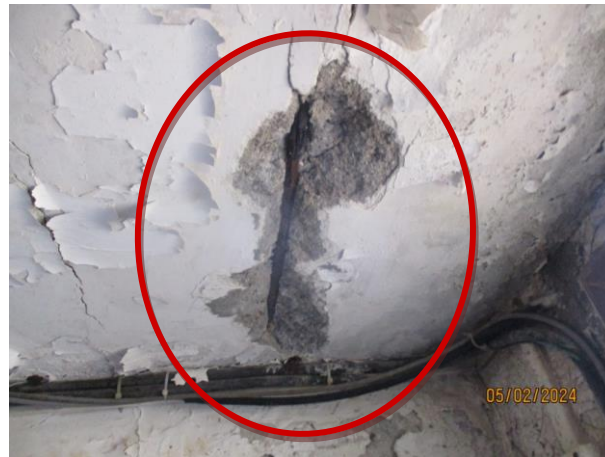
STAIRCASE BOTTOM AREA - CORRODED STEEL BARS EXPOSED AT CEILING

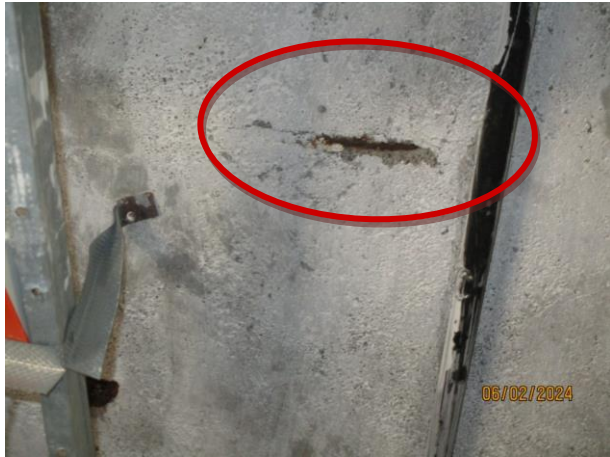
TOILET - CORRODED STEEL BARS EXPOSED AT CEILING

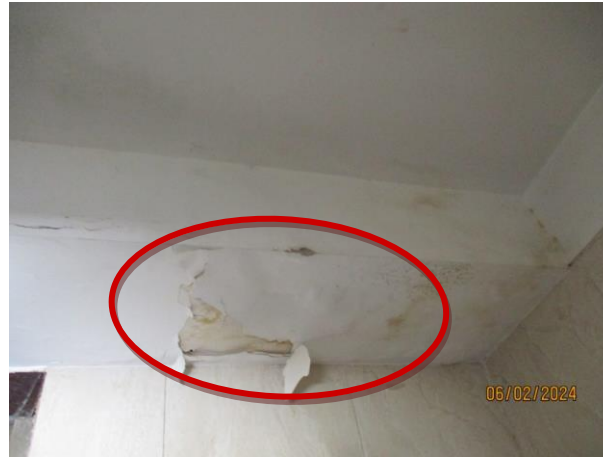
TOILET - FLAKING OF PSINT AT CEILING
