STRUCTURAL AUDIT REPORT WITH
RECOMMENDATION LETTER
DATE:- 13/02/2024 FOR
PARSEE GYMKHANA (G+01), MARINE LINES,
MUMBAI - 400 002.

Sub: Submission of single page entire report summary for visual survey & structural audit of Parsee Gymkhana, Marine Lines.

Details of structure: - The building constitutes of Ground + 1 Floors (RCC composite load bearing Frame Structure)

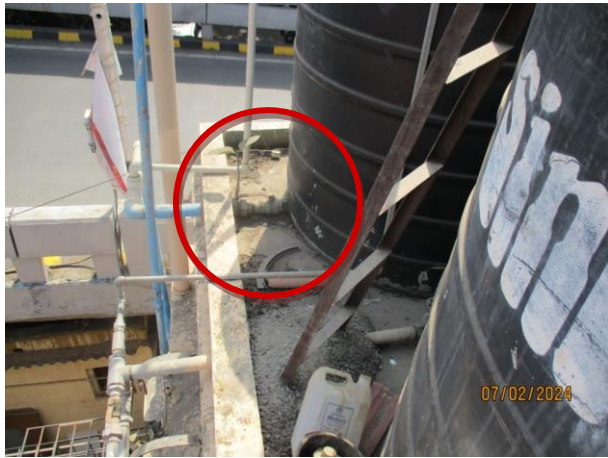
VEGETATION GROWTH FROM AT PLUMBING LINES

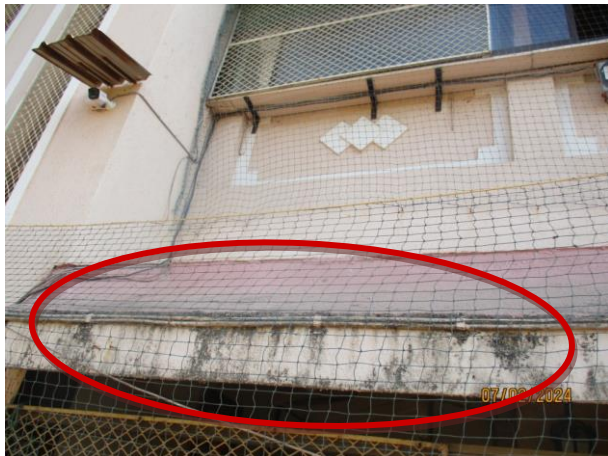
BLACK FUNGUS AT WALL PLASTER

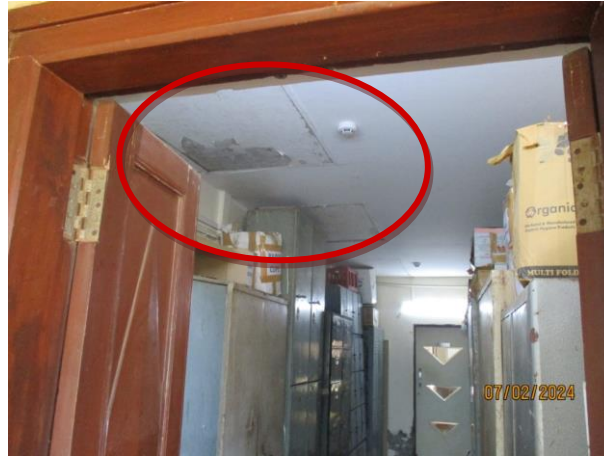
FLSKING OF PAINT AT CEILING

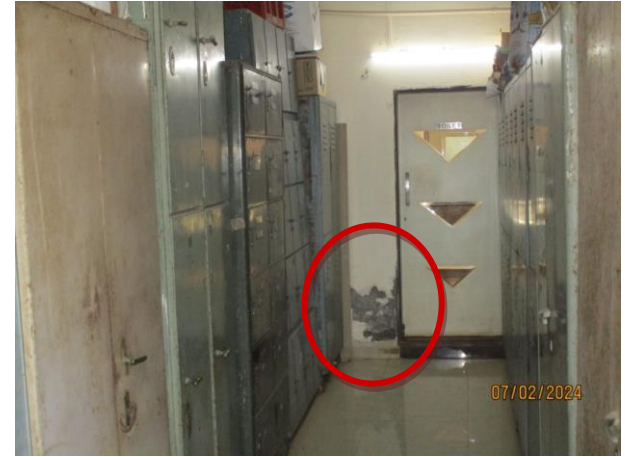
CRACSK & FLAKING OF PAINT AT WALL

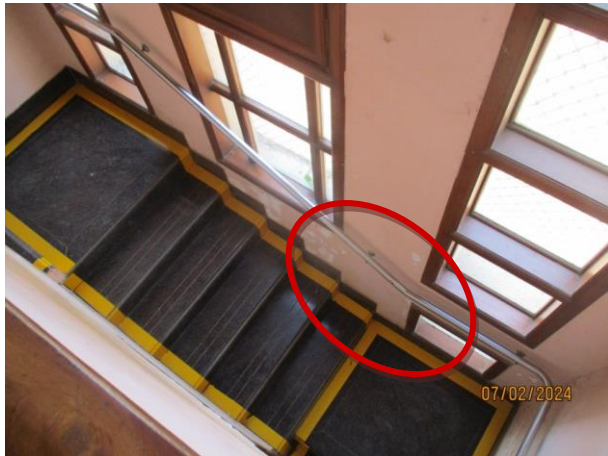
FLAKING OF PAINT AT WALL

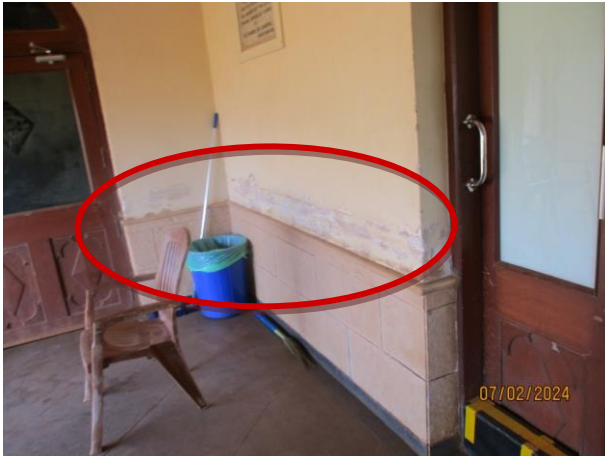
FLAKING OF PAINT AT WALL

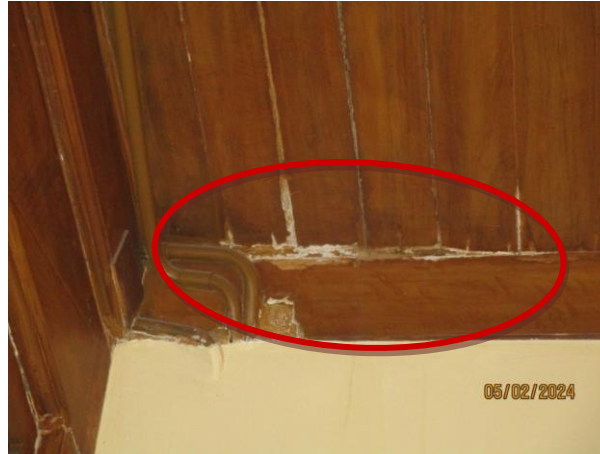
BANQUET HALL - SEEPAGE MARKS AT WOODEN CEILING

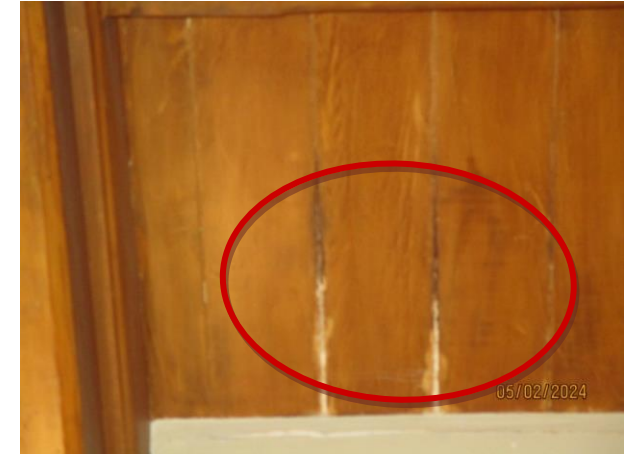
BANQUET HALL - SEEPAGE MARKS AT WOODEN CEILING

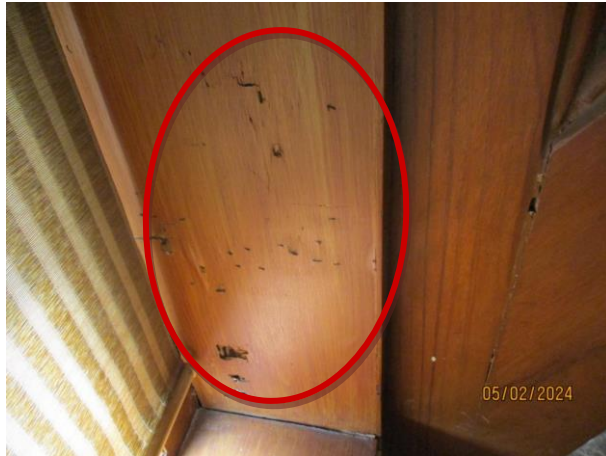
BANQUET HALL - BAD CONDIRION OF CEILING

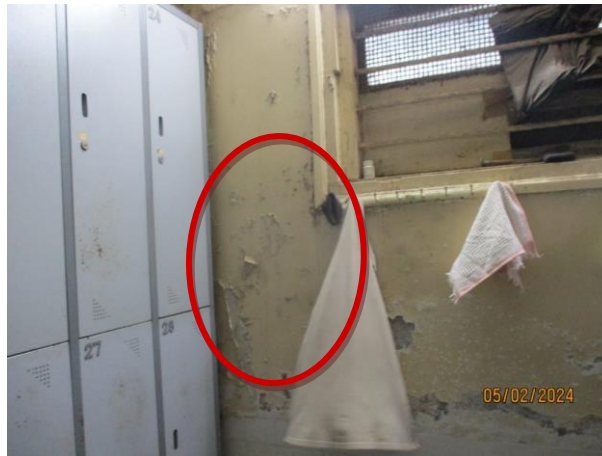
**BADMINTON ROOM - FLAKING OF PAINT AT
WALL**

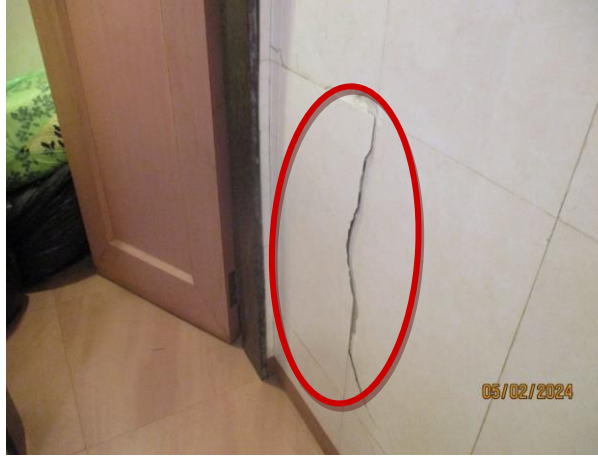
BADMINTON ROOM - CRACKS AT WALL PAINT

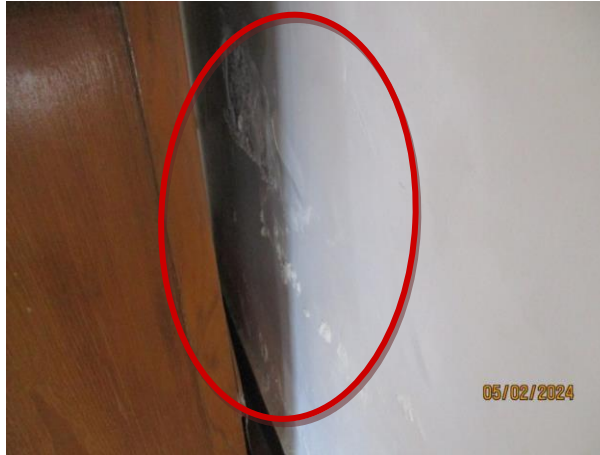
BILLIARD ROOM - FLAKING OF PAINT AT WALL

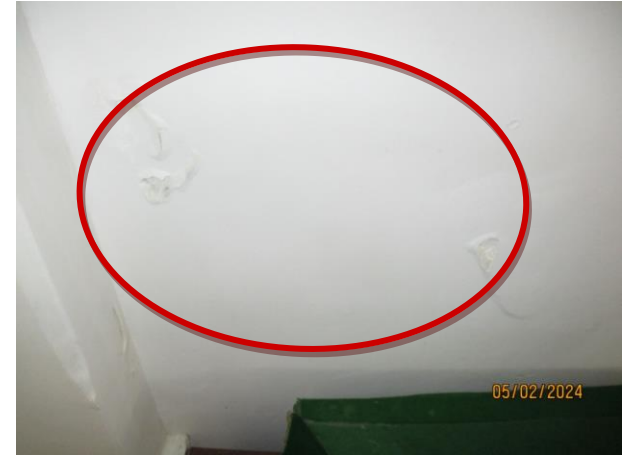
BILLIARD ROOM - PAINT PEELING AT CEILING

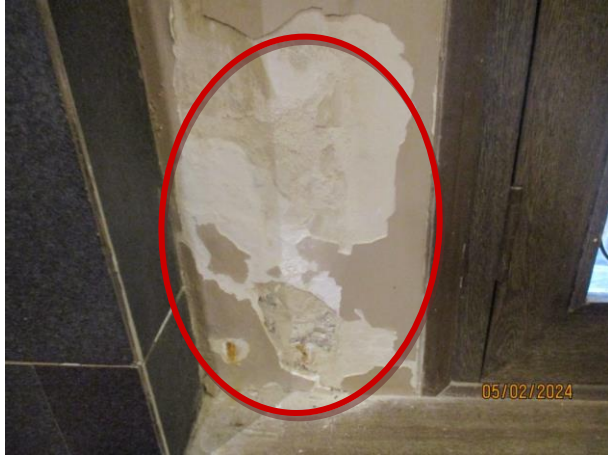
CLEAN BOWL (DINING ROOM) - FLAKING OF PAINT AT WALL

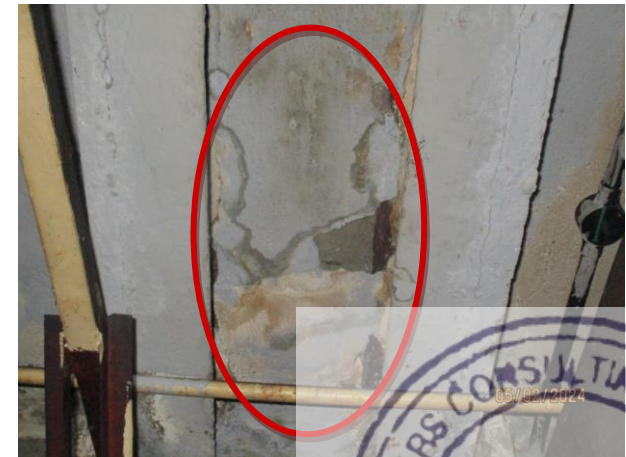
CLEAN BOWL (DINING ROOM) - FLAKING OF PAINT AT CEILING

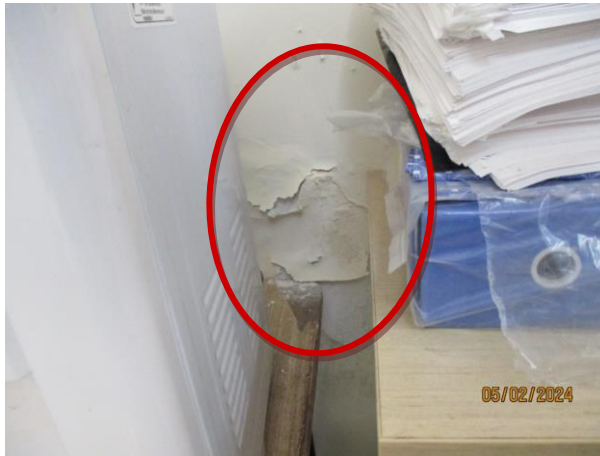
GYMKHANA OFFICE - FLAKING OF PAINT AT WALL

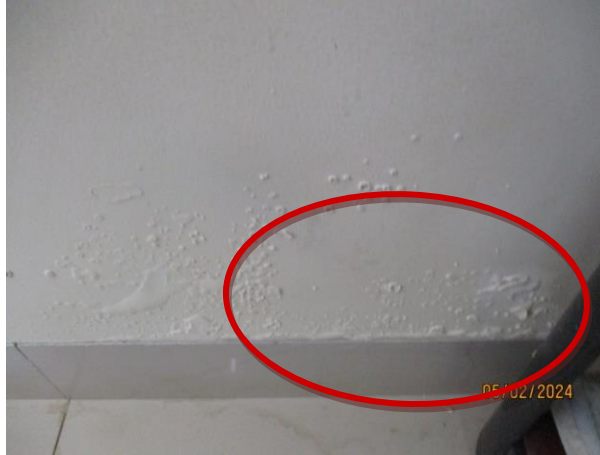
SECRETARY OFFICE - CRACKS AT WALL

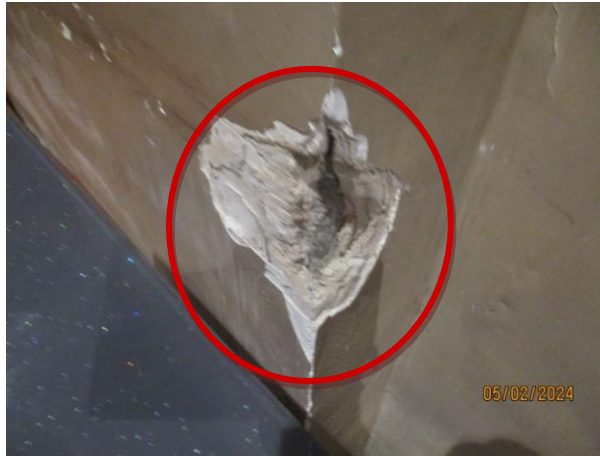
SILLY POINT (BAR) - FLAKING OF PAINT AT WALL

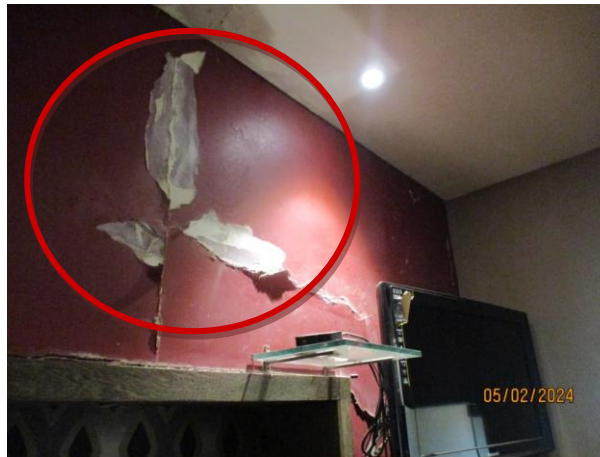
SILLY POINT (BAR) - FLAKING OF PAINT AT WALL

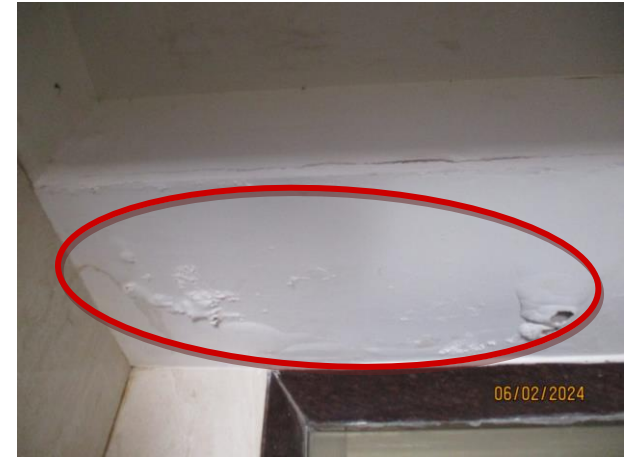
TOILET - FLAKING OF PSINT AT CEILING
