STRUCTURAL AUDIT REPORT WITH
RECOMMENDATION LETTER
DATE:- 13/02/2024 FOR
PARSEE GYMKHANA (G+01), MARINE LINES,
MUMBAI - 400 002.

Sub: Submission of single page entire report summary for visual survey & structural audit of Parsee Gymkhana, Marine Lines.

Details of structure: - The building constitutes of Ground + 1 Floors (RCC composite load bearing Frame Structure)

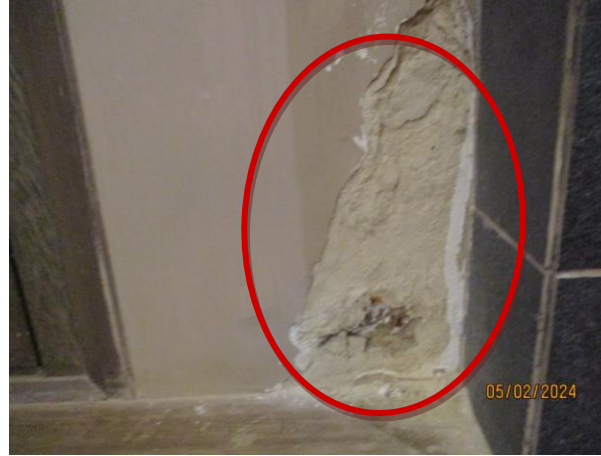
CLEAN BOWL (DINING ROOM) - FLAKING OF PAINT AT WALL
